## WGSL Sedimentation Basin Restoration Addendum Report

Subject: Sedimentation Basin Restoration Observation Report Addendum, Waimanalo  
Gulch Sanitary Landfill, Kapolei, HI

**Subject: Work Plan for Sedimentation Basin Restoration- Waimanalo Gulch  
Sanitary Landfill, Ewa Beach, Oahu, HI**

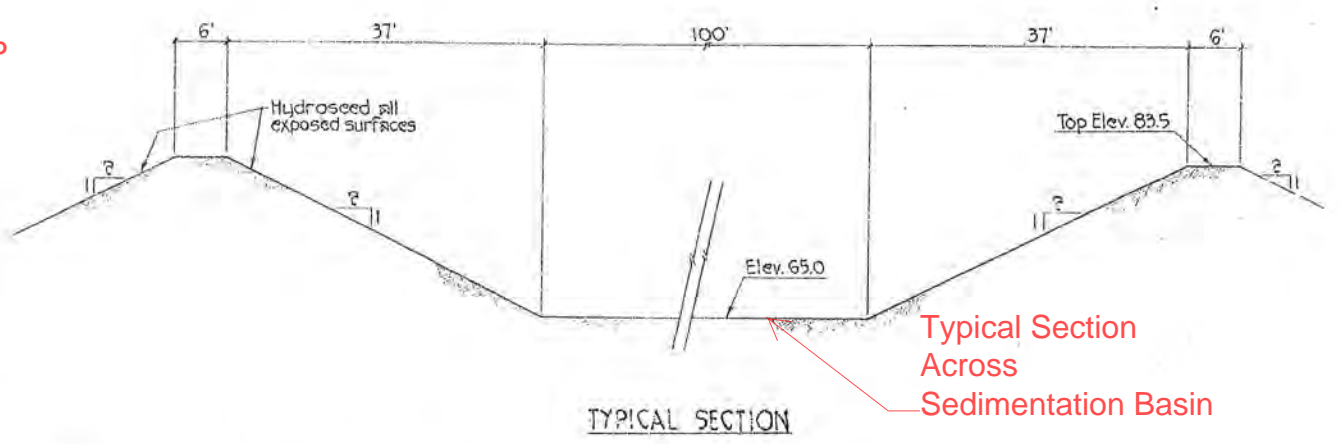
TYPICAL SECTION

Original CMP Riser Pipe Replaced with Concrete Riser (See EarthTech Drawing C-11)

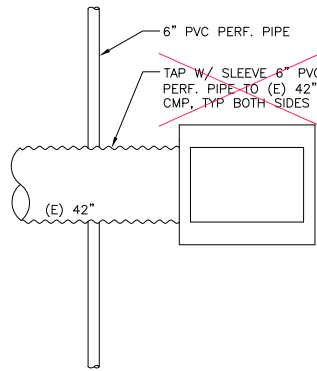
**6" HDPE PERF PIPE CONNECTS DIRECTLY INTO CONC. VAULT THROUGH PRE-CAST HOLES. ANNULAR SPACE SEALED WITH GROUT.**

- 6) In performing the restoration 4-inch diameter perforated HDPE pipe was used in the subdrain rather than the 6-inch noted in the design drawings because the existing (“as-built condition”) was found to be 4-inch pipe. Please provide either an engineering analysis that confirms this change in pipe size is adequate to conform to the original design basis, or replace the 4-inch diameter pipe with the 6-inch size included in the approved Work Plan.
